Neutral Citation Number: [2020] EWHC 3334 (Comm)

IN THE HIGH COURT OF JUSTICE

GLOBAL TECHNOLOGIES RACING LIMITED

**5 WEST LIMITED (t/a ALEX THOMSON
RACING)**

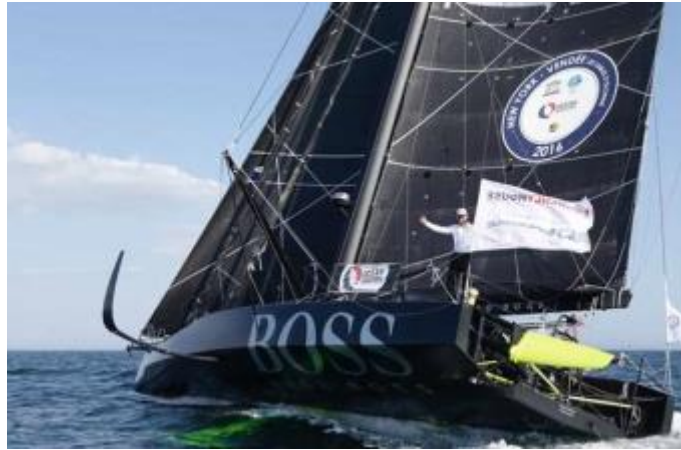
36. The hydrofoil is a removeable part, principally made of carbon fibre reinforced plastic, projecting from the side of the boat. The V1 port foil can be seen on the Boat in the photograph at page 3 of a document within the trial bundle called ATR T2 Foil Timeline at **628/610**. It is described by Mr Smith as being similar to a springboard.

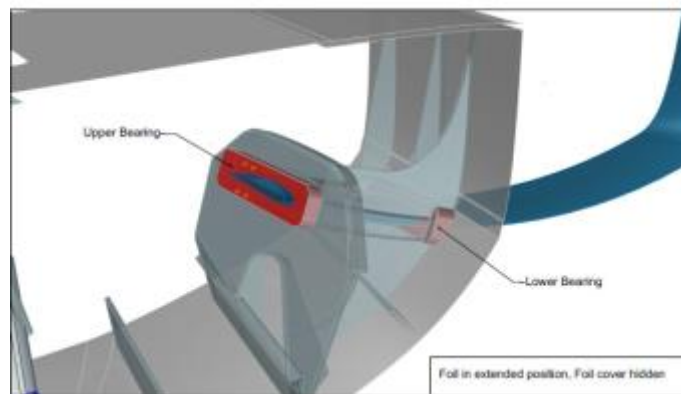
37. The foil is attached to the boat via two bearings, the upper bearing inside the boat and the lower bearing in the hull shell. Mr Smith illustrates this at paragraph 5.4 of his report at **552/534**.

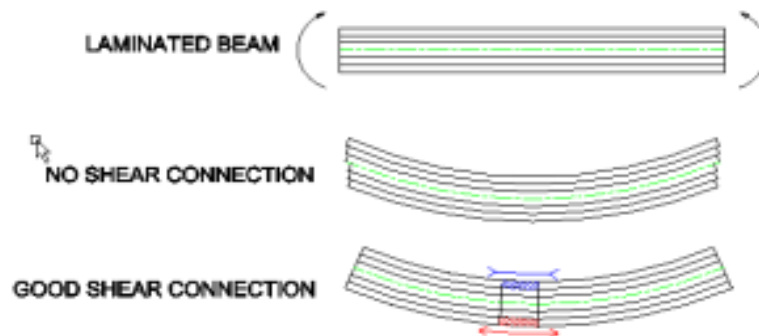
43. The force created by bending of the beam, known as interlaminar shear stress, will tend to cause interlaminar shear (in other words separation of the layers) unless there is good shear connection. This is illustrated by Mr Smith at paragraph 4.4.6 of his report (548/530).

With no shear connection, one can see how the laminates tend to debond creating a ragged end of separate layers, whereas with good shear connection, the laminates stay bonded in a neat line. The capacity of the material to do this is called inter-laminar shear strength.
